Disaster Preparedness for Effective Response

Agronomic Rehabilitation and Livelihood Restoration of Tsunami Affected Lands in Nagapattinam District of Tamil Nadu

M.S.Swaminathan Research Foundation
Chennai

August 2006

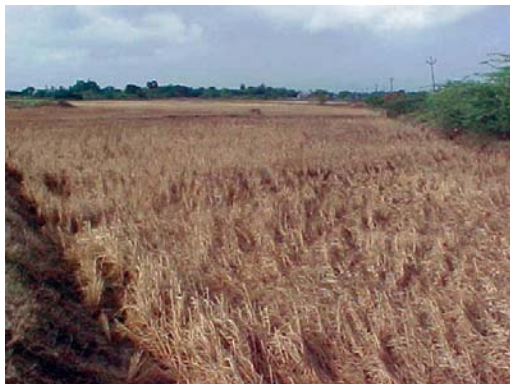
Paddy field

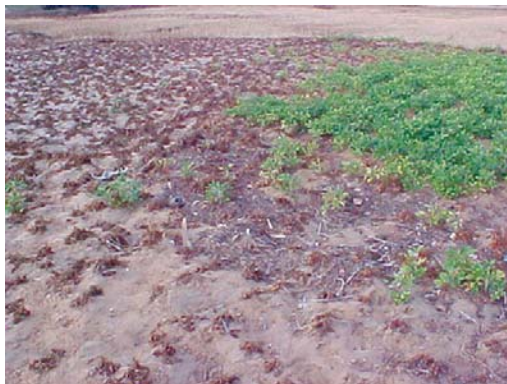
Groundnut field

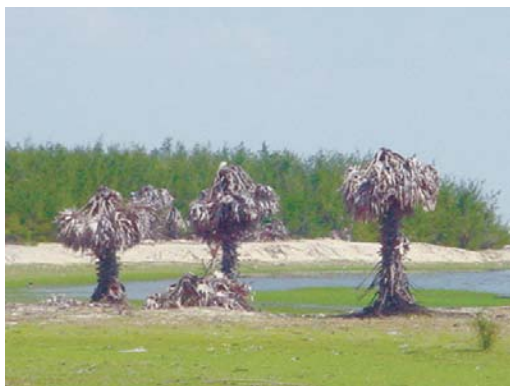
Palmyra tree

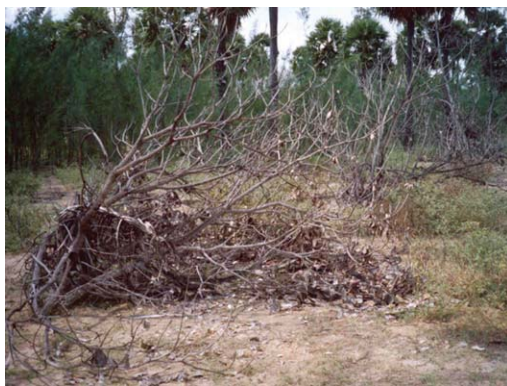
Cashew tree

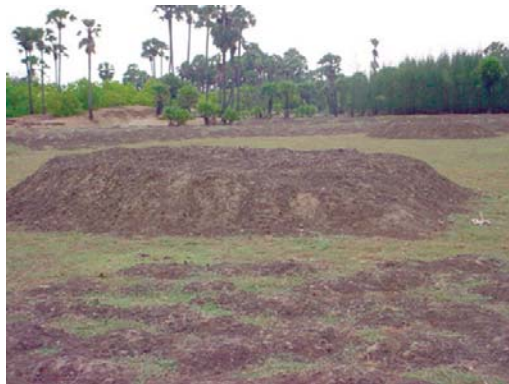
Heap of clay encrustation

- The deposit can be mixed with soil by ploughing and it will improve soil texture especially of the surface soil, water holding capacity and soil fertility. The incorporation of deposited material will not act as physical barrier since it forms crack on drying and after mixing. The higher amount of salts will get leached down after the rainy season and thus it will not be a permanent source of salts, which could affect the root growth.
- In some of the farmer's fields the deposit was scrapped and kept in the field itself as heaps. It should be spreaded and incorporated into the soil to avoid the development of localized salinity.

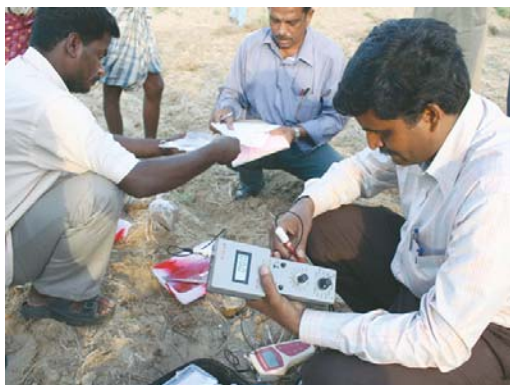
Spot measurement

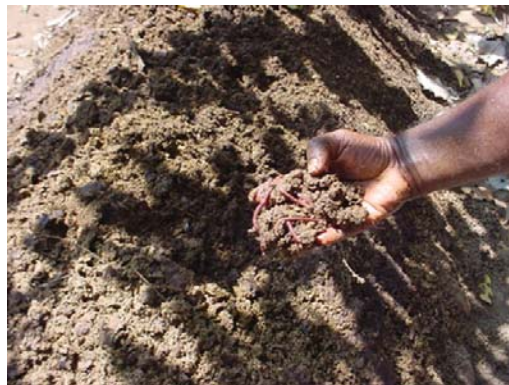
Application of vermicompost

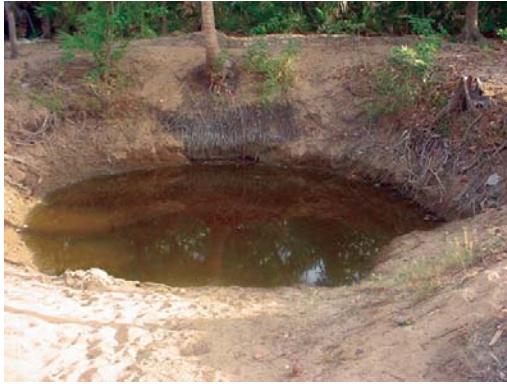
Tsunami affected farm pond

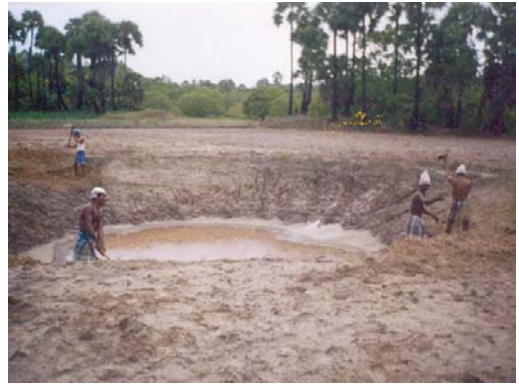
Removing the saltwater and desiltation

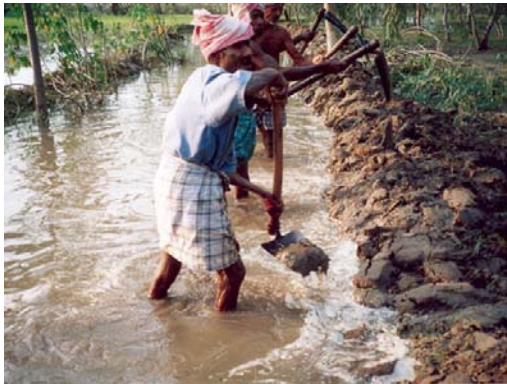
Desilting the irrigation canal

- *Providing proper drainage facilities:* In many of the fields the water drainage was blocked with debris and sediments. These were removed and clean drainage was restored.

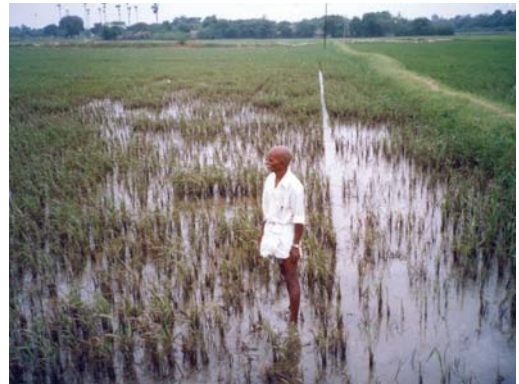
Imundated Paddy field

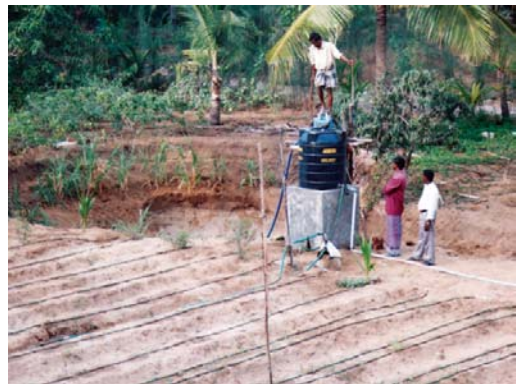
Pedal pump - Gravity drip irrigation method introduced

- *Gravity drip system was introduced to enhance water use efficiency* of the farm ponds.

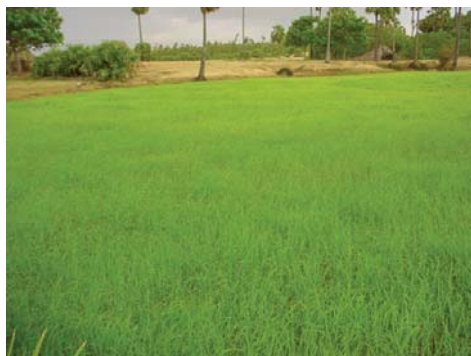
Paddy traditional land race -
Kulivedichan

- *Selection of salt-tolerant varieties:* Paddy varieties that can tolerate salt water intrusion, like TRY 2, CO 43, MDU 5, ADT 43, and traditional landraces like *kuzhivedichan*, were grown wherever possible; the transplanted method of cultivation was followed.

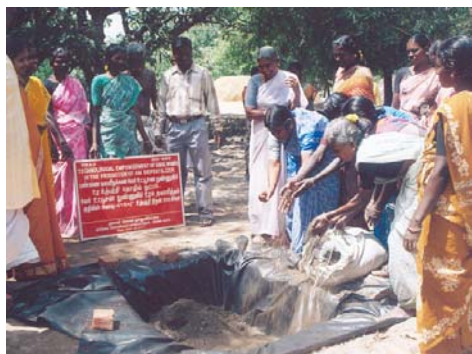
Production of Arbuscular Mycorrhiza
