MANGROVE FOREST RESTORATION IN ANDHRA PRADESH INDIA

Mangrove Forest Restoration in Andhra Pradesh, India

MSSRF/MA/04/13

August 2004

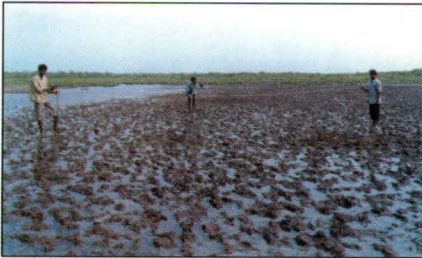
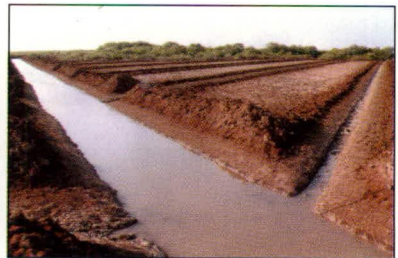
The main canals were dug at an angle of 45° to the natural creek. The side canals were dug at an angle of 30° to the main canal. Pegs and chalk powder were used for marking the canals.

Canals were designed like fishbone in order to facilitate easy inflow and outflow of tidal water. The design for the canal for mangrove restoration is given in Fig.1. The canal dimensions were

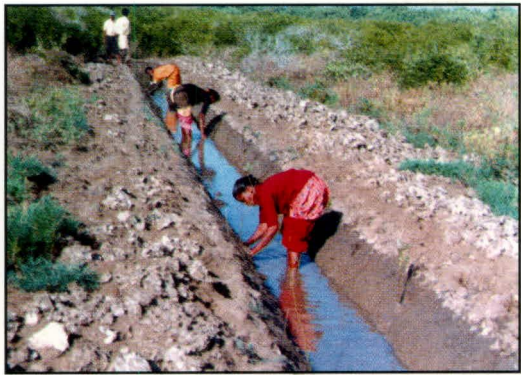
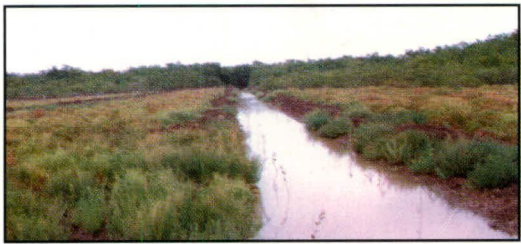
planted to ensure genetic diversity. Eight-month-old mangrove saplings raised in the nursery were used for planting. The mangrove saplings were planted along the slopes (20-25 cm from the top) of the canals with a gap of 2 m.
